COMMUNITY HEALTHCARE

TECHNICAL ASSIGNMENT II

KENNA MARKEL

The Pennsylvania State University
Architectural Engineering
Construction Option

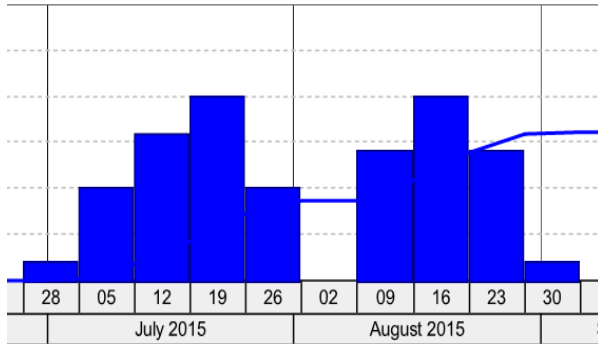
Figure 2 Manpower Gap

moved from one side to the next. This creates a manpower drop off between the construction of the west and north façade and the east and south side at the beginning of August 2015 (as seen in Figure 2); however, this correlates with only have one side’s worth of tube scaffolding and one side of hydraulic scaffolding. Fortunately, the site allows for the materials to be delivered long before they are needed for installation, which causes no delays waiting on materials. The site has the workers during the installation of brick up to thirty masons, which seems to be a lot, including the support crews, foreman, and a full-time quality control manager.

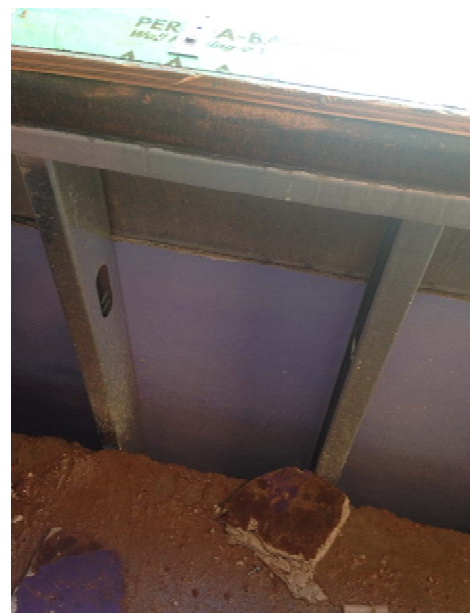
Figure 3 Shows 5 inch gap

Most of the major constructability issues were a product of poor design and lack of prior constructability surveying. The first major issue discovered when constructing the façade was during framing. The standard framing specified for the project was a 6 inch metal stud, however, when it came to installing the exterior framing the west and east sides only had a 5 inch space for the framing to fit from the slab to the building edge. This issue is show in Figure 3 (right). Since this 5 inch gap will not accommodate a 6 inch stud, the project team had to submit an alternative solution for approval to the design team. Since the framing design was delegated to the drywall subcontractor, the framers submitted a design to install 4 inch studs on the exterior of the west and east façade in place of the 6 inch stud. While this solution was ultimately approved by Perkins +Will, the additional time needed to determine the solution,

submit the alternative, get an approved submittal, and delivery the new material delayed the installation of the façade on the west side by a month.

The façade is being installed from the west elevation clockwise to the north then east then south facades. Before beginning to install the façade, a major issue was discovered. It was found that while the design called for six inch metal framing, the gap between the slab and building edge on the west and east sides was only five inches. The solution was to use four inch metal framing for the west and east side while using six inch framing everywhere else including the north and south side. So instead of beginning framing on the west elevation, the carpenters had to begin on the north elevation then backtrack to the west side once submittals were approved and material delivered. The framing, sheathing, and spray on vapor barrier was installed by way of lifts to prepare for the installation of the brick veneer.
